Utility Pole Woodpecker Damage and the Impact on Electric Co-ops

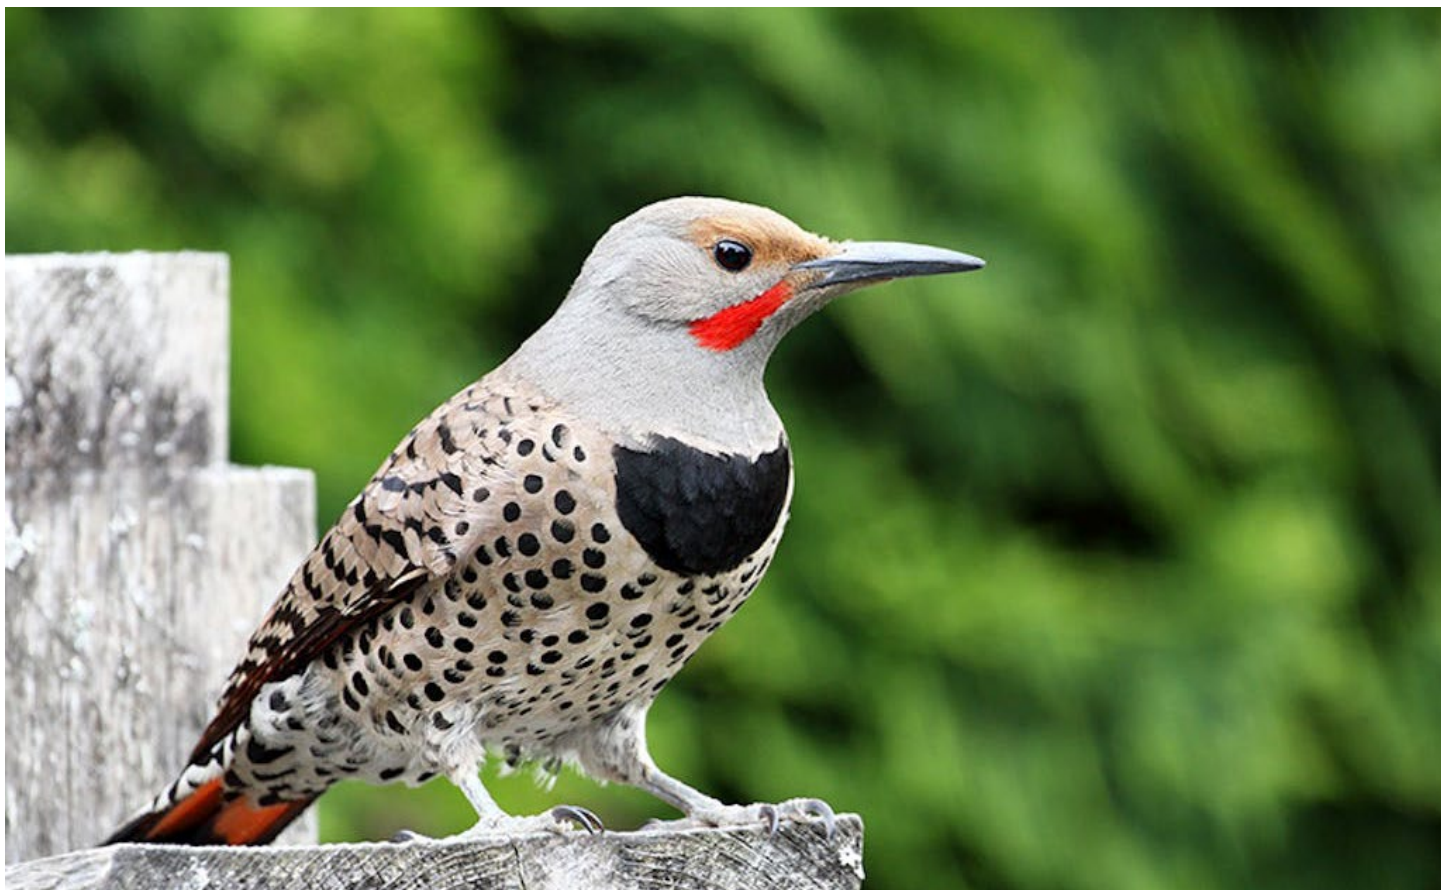
Woodpecker damage from birds like the Northern Flicker (pictured above) can weaken your infrastructure over time. Keep your poles healthy and strong with regular inspections and repairs.

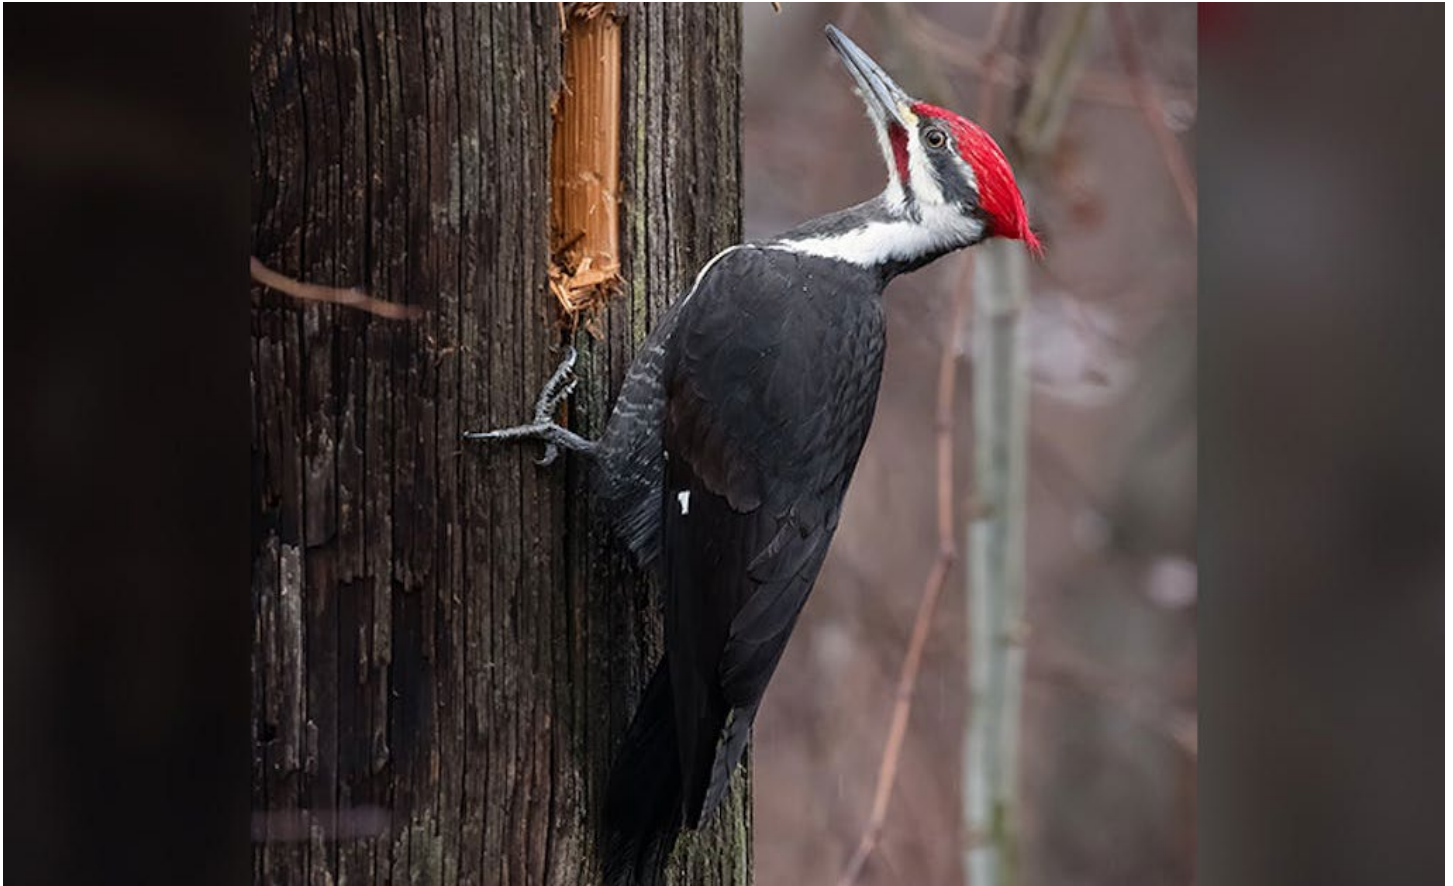
In general, a bird hole that is more than two inches in diameter can compromise the structural integrity of an electric wood pole, especially if the hole is located in a critical area of the pole or if there are multiple holes in close proximity to each other.

These holes may seem small, but they can cause serious damage when drilled into utility poles.

However, it's important to note that even smaller holes can lead to moisture penetration and decay, which can weaken the pole over time and make it more susceptible to failure during high winds or other extreme weather events.
